Manhole Inspection Summary

Manhole # S35WW_011MH

Location Address: **3120 GUILFORD AVE**

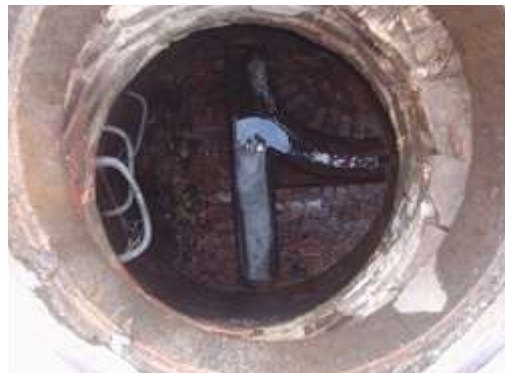
Top View

Evidence of surcharge - Bench debris.
Channel debris.

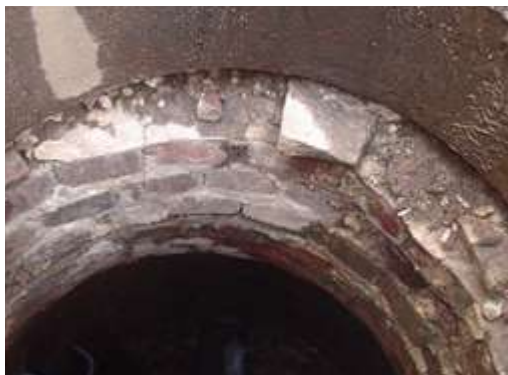
Defect

Frame leaks. Frame leaks. Adjustment
deterioration, loose brick and infiltration -
other side.

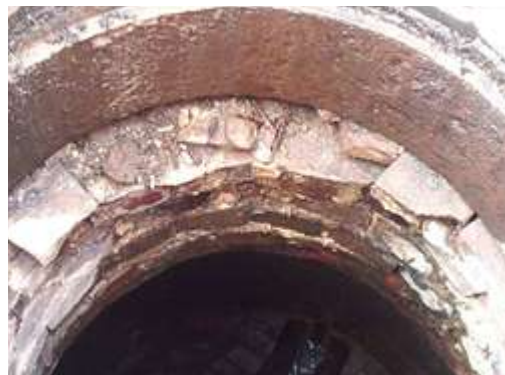
Defect

Frame leaks. Frame leaks. Adjustment
deterioration, loose brick and infiltration.
Corbel infiltration.

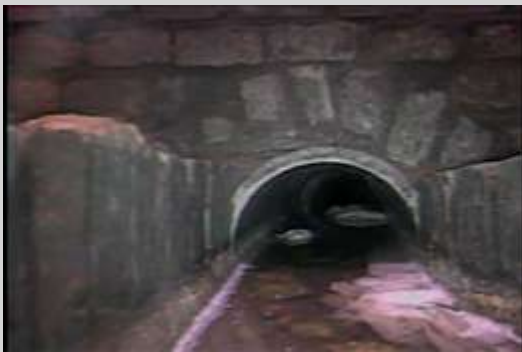
8 in. Circular Gravity Sewer Pipe Out @ 12 O'Clock

Deposits: ☐ None ☒ **Mud** ☐ Sludge ☒ **Debris** ☐ **Grease**

Silt Depth: **2** (in.) Deposits Extent: **Light**

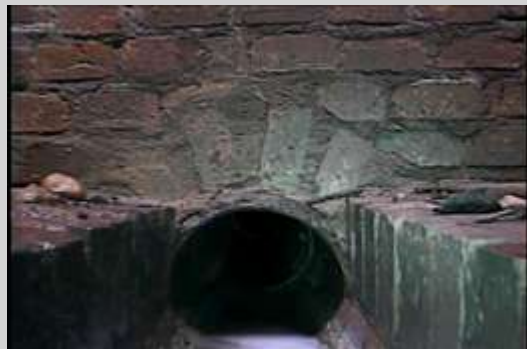
8 in. Circular Gravity Sewer

Deposits: ☐ None ☐ Mud ☐ Sludge ☐ Debris ☒ **Grease**

Deposits Extent: **Light**
